Garage Door Warning – some door openers improperly installed

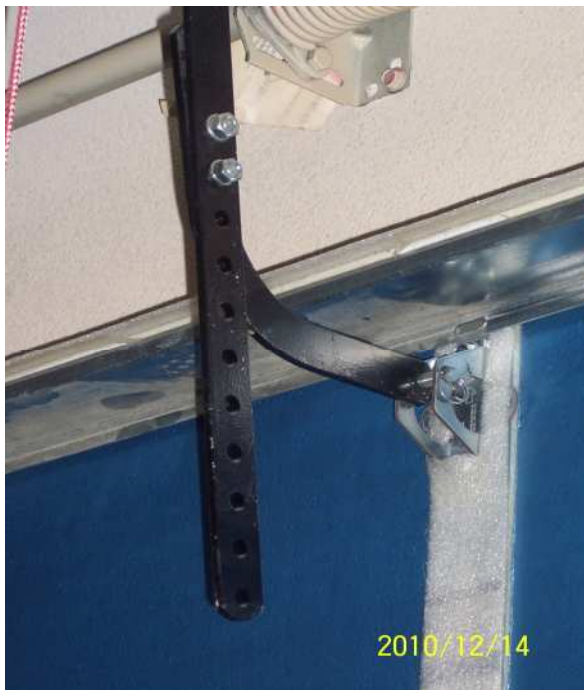
Jim on Da Vinci had the top two panels of his garage door damaged by his garage door opener. The door company that responded to his call said the connection from the opener track to the door had been improperly installed.

I took a picture of the new proper connection on Jim's door (picture on the top, before fix) and a picture of his neighbor's still improperly installed opener connection (picture on the bottom, after the fix).

There are two bars that connect the motor to the door. The straight one has 11 holes. The curved one has 3 holes. They are connected by two bolts.

The proper connection is for the bolts to be through the 8th and 11th holes of the straight bar, connecting it to the 1st and 3rd holes of the curved bar.
